## CASE STUDY- WE FIND PV ISSUES AND FAULTS

### EXAMPLE- 1. AVON FIRE AND RESCUE – HICKS GATE

**RWG SOLAR**  
Meter-based Monitoring

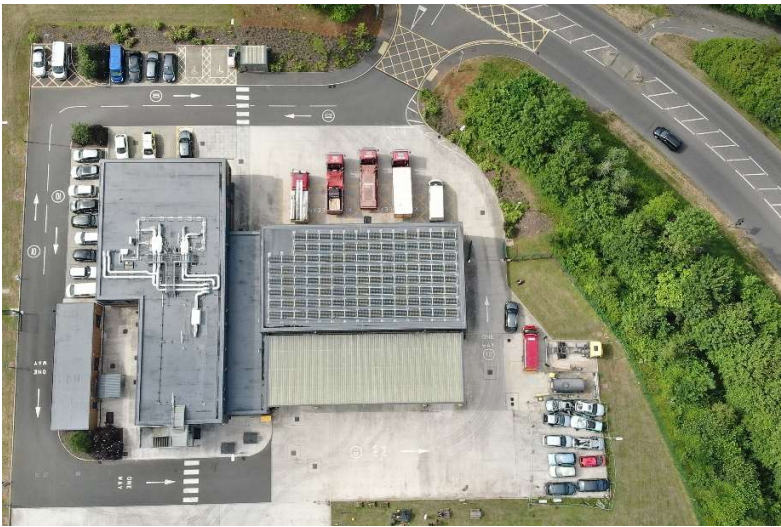
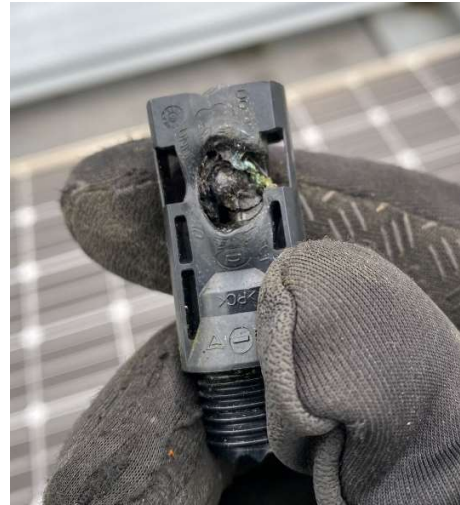
**AVON FIRE AND RESCUE @ HICKS GATE – VERY SAFETY CONSCIOUS – WE FOUND PARTIAL OPERATION.**

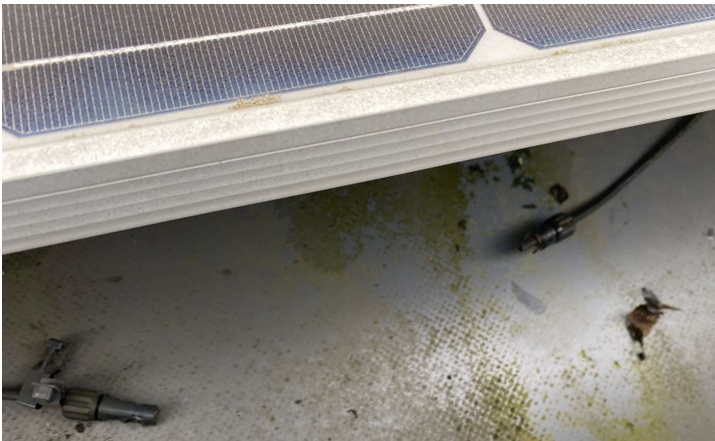
**FURTHER INVESTIGATION ON THE ROOF SHOWED UP 2 LOTS OF FAULTY STRINGS AND FIRE HAZARDS**

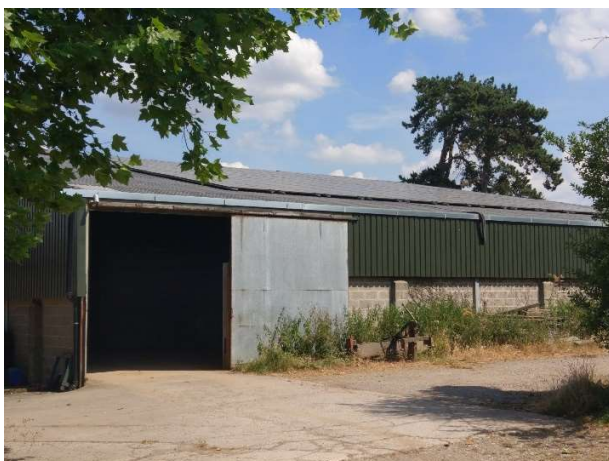
**DUCHY OF CORNWALL – MANOR FARM STRATTON ON THE FOSSE. WE DETECTED A LOT OF STRINGS DOWN, SO THESE WERE DISCONNECTED. FURTHER INVESTIGATION MEANT WE FOUND A**

**RODENT HABITAT CREATED BY INSTALLER. NOT SOLARSENSE!**

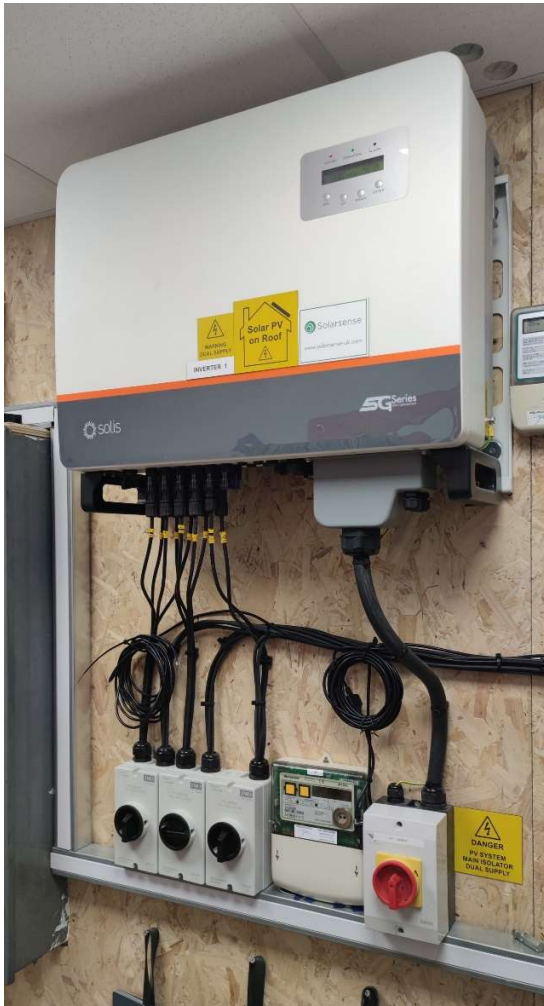
**RWG MONITORING TEAM DETECTED THE INVERTER WAS NOT WORKING.**

**IT TURNED OUT MIDDLE GROUP OF STRINGS WAS THE ISSUE. WE ISOLATED THEM.**

**AWAITING ROOF INVESTIGATION**
